# Home Report

| Property address | 14 Brodie Avenue<br>Dumfries<br>DG2 7ED |
| Prepared by | Shepherd Chartered Surveyors |
| Date of inspection | 08/07/2026 |

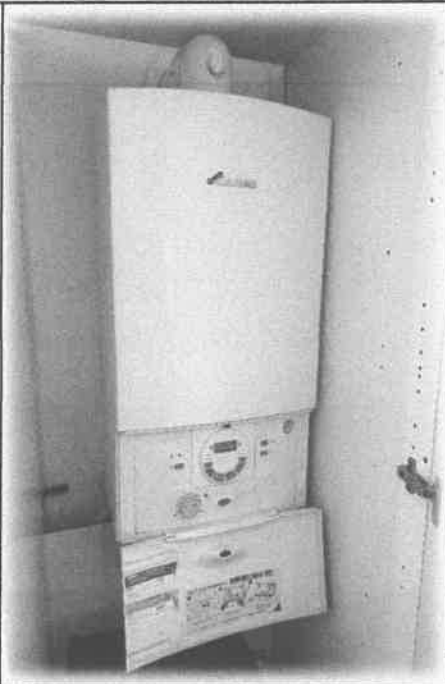
| Hot Water Survey Section | | |
|---|---|---|
| Asset ID | Combi Boiler (CB01) | |
| Location | Bedroom Cupboard | |
| Make/Model | Worcester | |
