# Home Report

| Property address | 14 Brodie Avenue<br>Dumfries<br>DG2 7ED |
| Prepared by | Shepherd Chartered Surveyors |
| Date of inspection | 08/07/2026 |

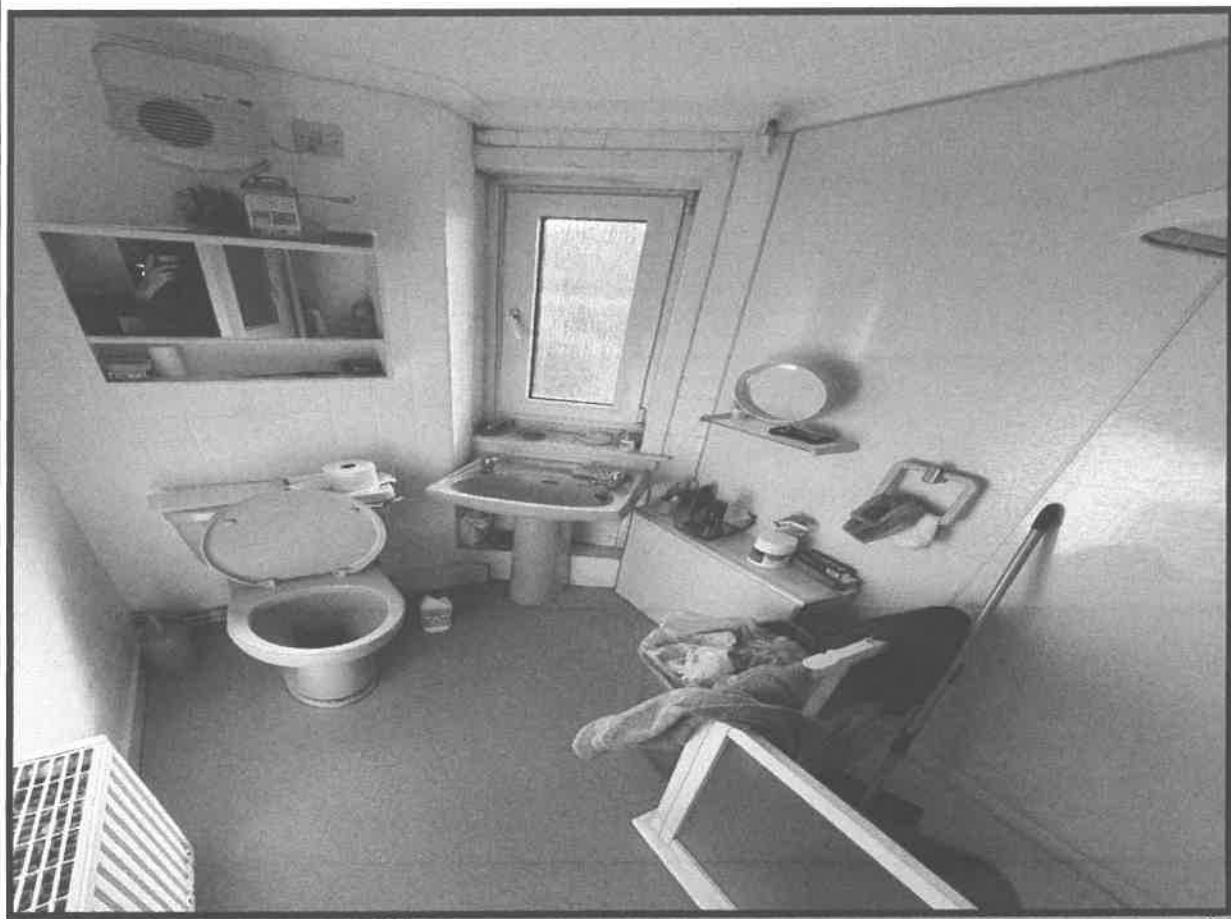
**Note** – An infrequently used outlet (IUO) is a hot or cold outlet that has not been used within 7 days. Infrequently used outlets that are not flushed weekly can cause stagnation, thus increasing the risk of Legionella proliferation.

Ensure they are flushed weekly for 1 - 5 minutes, depending on the length of the pipework, especially showers.

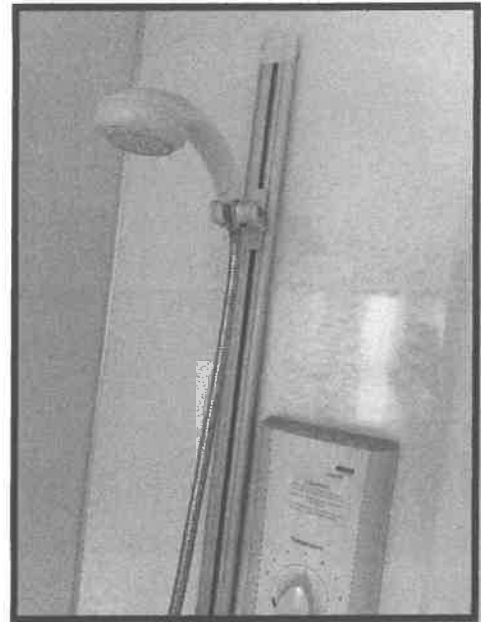
**Note** – Showerheads act as a filter, trapping dirt and debris; this provides a source of nutrients for Legionella and increases the risk of proliferation. In addition to this, the shower also creates tiny droplets/aerosols that can be inhaled deep into the lungs.

A disinfectant/de-scaler should be used to remove the scale trapped within the showerhead (not bleach). *Showerhead plus* is a commonly used de-scaler/disinfectant. It is imperative that showerheads are cleaned and descaled every 3 months.
