HOME REPORT

FLAT 1/5
170 ELMBANK STREET
GLASGOW
G2 4NY

DM HALL
CHARTERED SURVEYORS

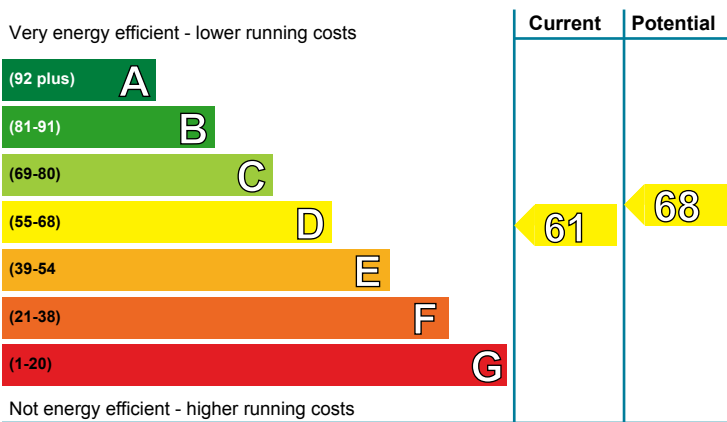
Energy Efficiency Rating

This graph shows the current efficiency of your home, taking into account both energy efficiency and fuel costs. The higher this rating, the lower your fuel bills are likely to be.

Your current rating is **band D (61)**. The average rating for EPCs in Scotland is **band D (61)**.

The potential rating shows the effect of undertaking all of the improvement measures listed within your recommendations report.

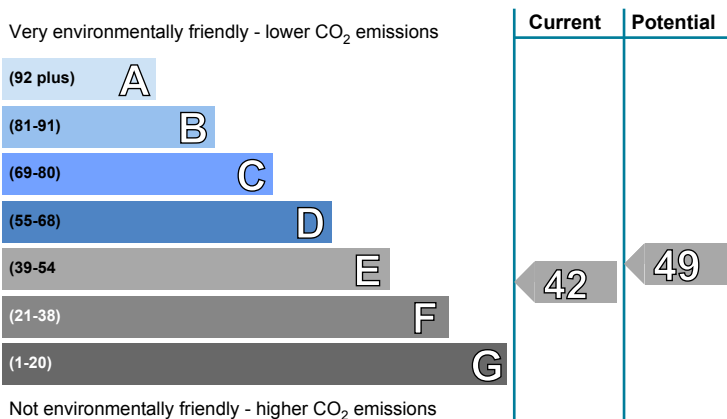
Environmental Impact (CO₂) Rating

This graph shows the effect of your home on the environment in terms of carbon dioxide (CO₂) emissions. The higher the rating, the less impact it has on the environment.

Your current rating is **band E (42)**. The average rating for EPCs in Scotland is **band D (59)**.

The potential rating shows the effect of undertaking all of the improvement measures listed within your recommendations report.
