20 WEST LOCHAN
SANQUHAR
DG4 6DQ

Home Report

Energy Performance Certificate (EPC)

Scottish Single Survey

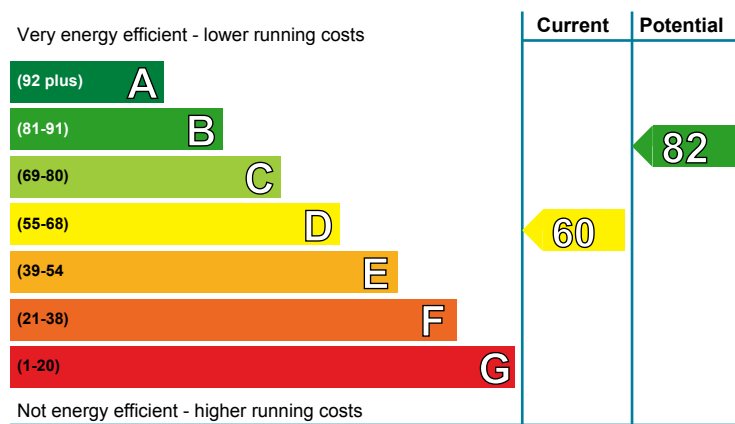
Energy Efficiency Rating

This graph shows the current efficiency of your home, taking into account both energy efficiency and fuel costs. The higher this rating, the lower your fuel bills are likely to be.

Your current rating is **band D (60)**. The average rating for EPCs in Scotland is **band D (61)**.

The potential rating shows the effect of undertaking all of the improvement measures listed within your recommendations report.

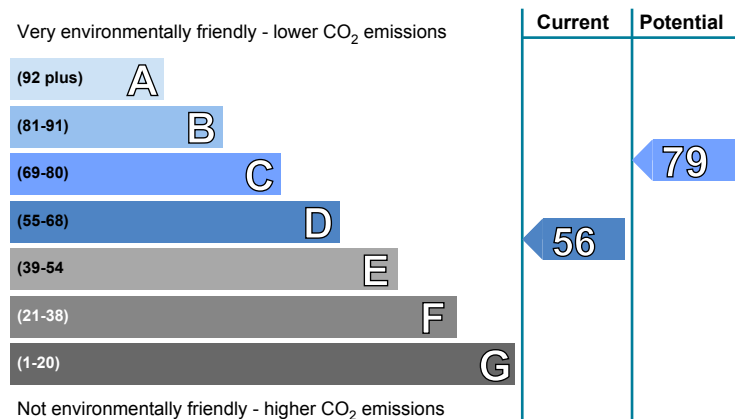
Environmental Impact (CO₂) Rating

This graph shows the effect of your home on the environment in terms of carbon dioxide (CO₂) emissions. The higher the rating, the less impact it has on the environment.

Your current rating is **band D (56)**. The average rating for EPCs in Scotland is **band D (59)**.

The potential rating shows the effect of undertaking all of the improvement measures listed within your recommendations report.
