# Home Report

# Scottish Single Survey

<b>Property address</b>	Kirkbrae Kirkgate Dunscore Dumfries DG2 0SZ
<b>Customer</b>	Harry Dalziel attorney for Ellen Keene
<b>Customer address</b>	Kirkbrae Kirkgate Dunscore Dumfries DG2 0SZ
<b>Prepared by</b>	Shepherd Chartered Surveyors
<b>Date of inspection</b>	24/03/2023

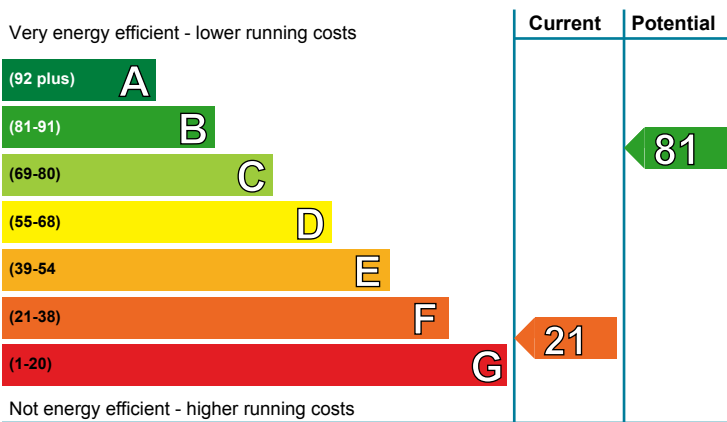
## Energy Efficiency Rating

This graph shows the current efficiency of your home, taking into account both energy efficiency and fuel costs. The higher this rating, the lower your fuel bills are likely to be.

Your current rating is **band F (21)**. The average rating for EPCs in Scotland is **band D (61)**.

The potential rating shows the effect of undertaking all of the improvement measures listed within your recommendations report.

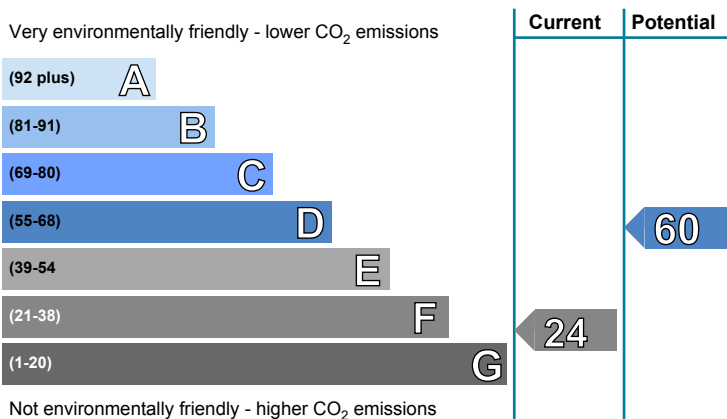
## Environmental Impact (CO<sub>2</sub>) Rating

This graph shows the effect of your home on the environment in terms of carbon dioxide (CO<sub>2</sub>) emissions. The higher the rating, the less impact it has on the environment.
