HOME REPORT

HOUSE AT HOLLYWOOD OLD HOLLYWOOD

HOLLYWOOD
DUMFRIES
DG2 0RA

Energy Performance Certificate (EPC)

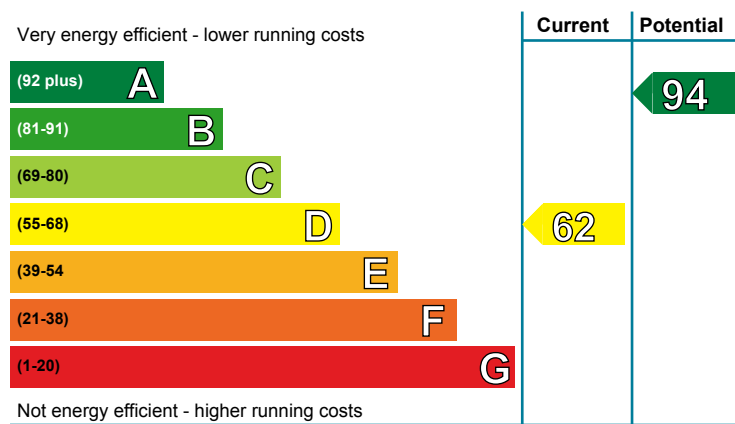
Energy Efficiency Rating

This graph shows the current efficiency of your home, taking into account both energy efficiency and fuel costs. The higher this rating, the lower your fuel bills are likely to be.

Your current rating is **band D (62)**. The average rating for EPCs in Scotland is **band D (61)**.

The potential rating shows the effect of undertaking all of the improvement measures listed within your recommendations report.

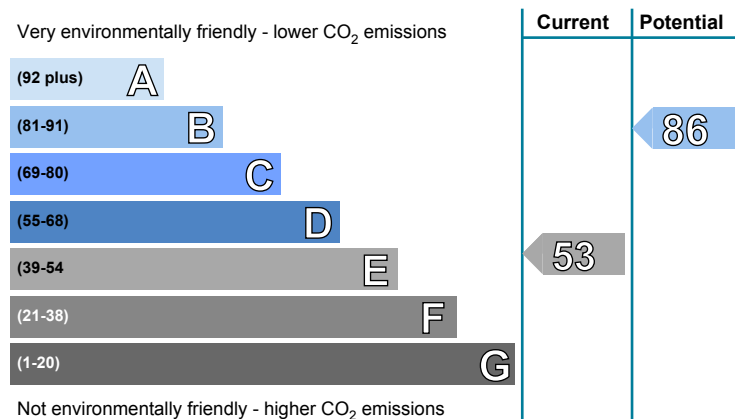
Environmental Impact (CO₂) Rating

This graph shows the effect of your home on the environment in terms of carbon dioxide (CO₂) emissions. The higher the rating, the less impact it has on the environment.

Your current rating is **band E (53)**. The average rating for EPCs in Scotland is **band D (59)**.

The potential rating shows the effect of undertaking all of the improvement measures listed within your recommendations report.
