Home Report

Scottish Single Survey

Property address	Keir Mill Thornhill DG3 4DE
Customer	Margaret Cruickshank
Customer address	Keir Mill Thornhill DG3 4DE
Prepared by	Shepherd Chartered Surveyors
Date of inspection	18/06/2024

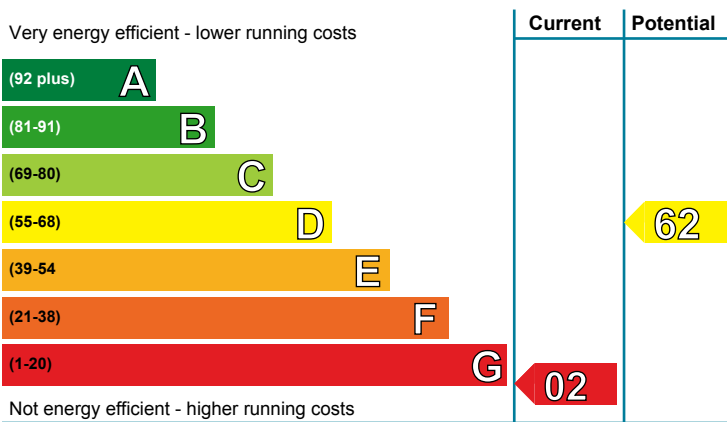
Energy Efficiency Rating

This graph shows the current efficiency of your home, taking into account both energy efficiency and fuel costs. The higher this rating, the lower your fuel bills are likely to be.

Your current rating is **band G (2)**. The average rating for EPCs in Scotland is **band D (61)**.

The potential rating shows the effect of undertaking all of the improvement measures listed within your recommendations report.

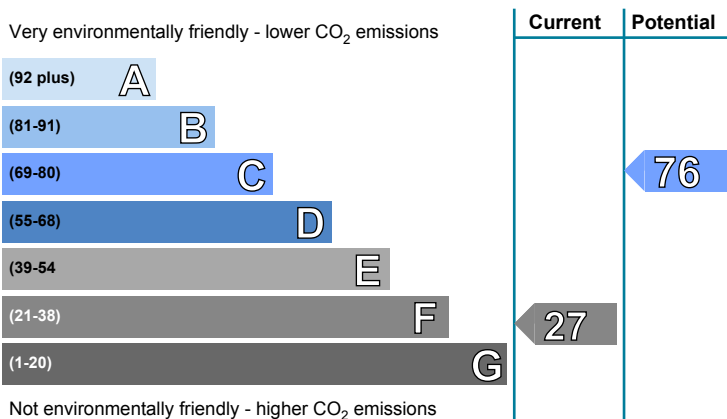
Environmental Impact (CO₂) Rating

This graph shows the effect of your home on the environment in terms of carbon dioxide (CO₂) emissions. The higher the rating, the less impact it has on the environment.
