# Home Report

# Scottish Single Survey

# Single Survey

<b>Property address</b>	23 Polveoch Terrace Kirkconnel Sanquhar DG4 6LX
-------------------------	--

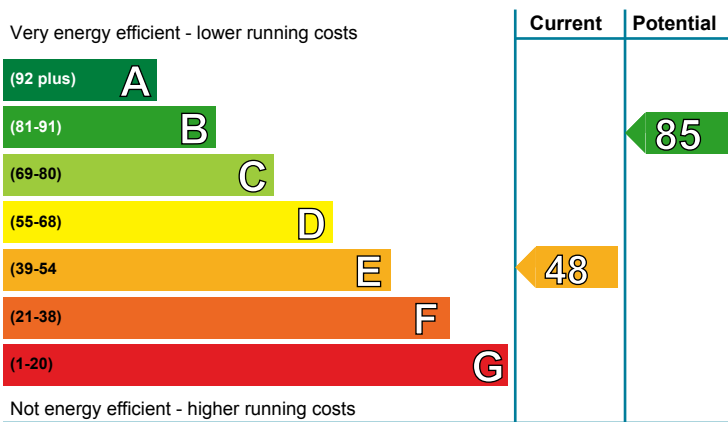
## Energy Efficiency Rating

This graph shows the current efficiency of your home, taking into account both energy efficiency and fuel costs. The higher this rating, the lower your fuel bills are likely to be.

Your current rating is **band E (48)**. The average rating for EPCs in Scotland is **band D (61)**.

The potential rating shows the effect of undertaking all of the improvement measures listed within your recommendations report.
