# Home Report

# Scottish Single Survey

<b>Property address</b>	5 Terregles Road Dumfries DG2 9HE
-------------------------	---

<b>Prepared by</b>	Shepherd Chartered Surveyors
--------------------	------------------------------

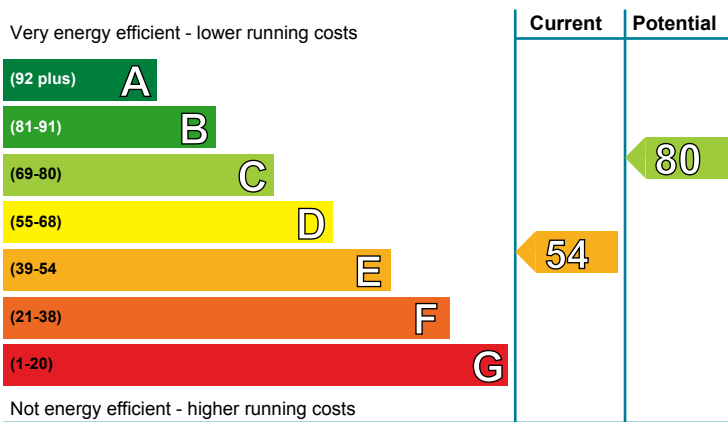
## Energy Efficiency Rating

This graph shows the current efficiency of your home, taking into account both energy efficiency and fuel costs. The higher this rating, the lower your fuel bills are likely to be.

Your current rating is **band E (54)**. The average rating for EPCs in Scotland is **band D (61)**.

The potential rating shows the effect of undertaking all of the improvement measures listed within your recommendations report.

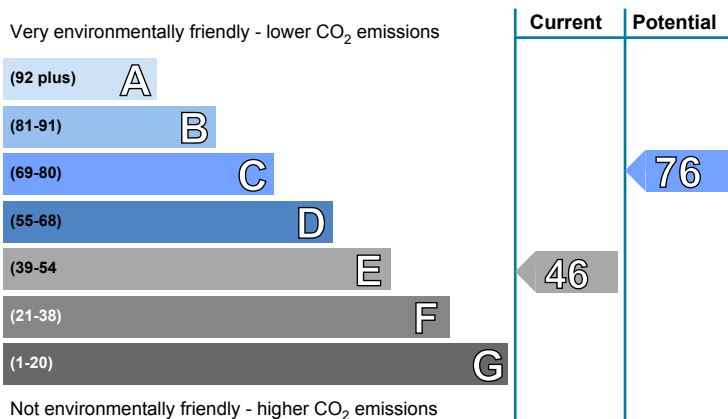
## Environmental Impact (CO<sub>2</sub>) Rating

This graph shows the effect of your home on the environment in terms of carbon dioxide (CO<sub>2</sub>) emissions. The higher the rating, the less impact it has on the environment.
