Home Report

Scottish Single Survey

Property address	The Willows Ruthwell Dumfries DG1 4NG
Customer	James Ritchie Deceased
Customer address	The Willows Ruthwell Dumfries DG1 4NG
Prepared by	Shepherd Chartered Surveyors
Date of inspection	12/08/2025

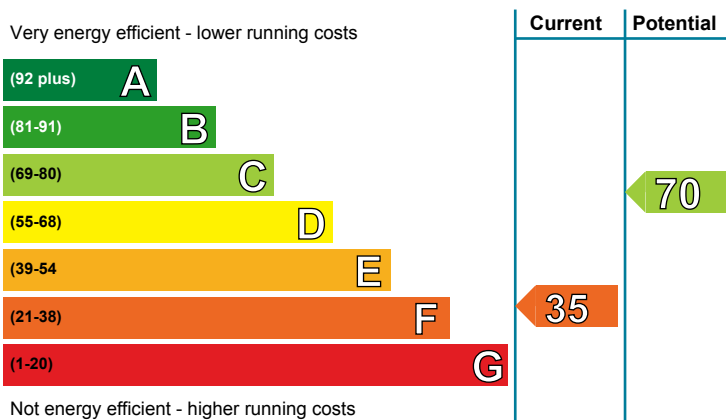
Energy Efficiency Rating

This graph shows the current efficiency of your home, taking into account both energy efficiency and fuel costs. The higher this rating, the lower your fuel bills are likely to be.

Your current rating is **band F (35)**. The average rating for EPCs in Scotland is **band D (61)**.

The potential rating shows the effect of undertaking all of the improvement measures listed within your recommendations report.
