Home Report

Single Survey

| Property address | 20 Grennan Road Penpont Thornhill DG3 4BS |
| Prepared by | Shepherd Chartered Surveyors |

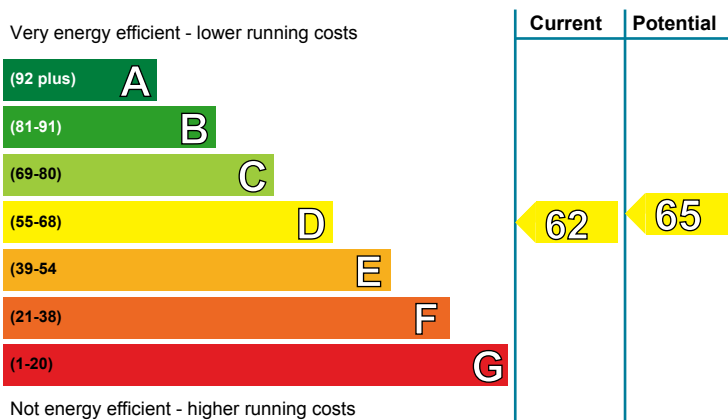
Energy Efficiency Rating

This graph shows the current efficiency of your home, taking into account both energy efficiency and fuel costs. The higher this rating, the lower your fuel bills are likely to be.

Your current rating is **band D (62)**. The average rating for EPCs in Scotland is **band D (61)**.

The potential rating shows the effect of undertaking all of the improvement measures listed within your recommendations report.
