Home Report

Scottish Single Survey

Property address	Ornockenoch Cottage Gatehouse Of Fleet Castle Douglas DG7 2BS
Customer	Christine Homes Executry
Customer address	Ornockenoch Cottage Gatehouse Of Fleet Castle Douglas DG7 2BS
Prepared by	Shepherd Chartered Surveyors
Date of inspection	07/10/2025

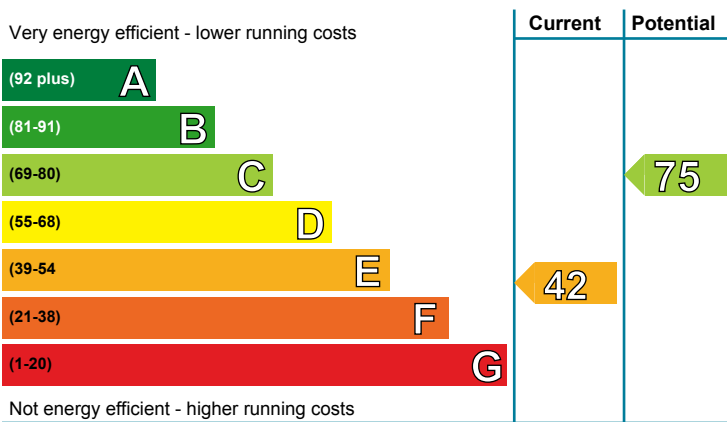
Energy Efficiency Rating

This graph shows the current efficiency of your home, taking into account both energy efficiency and fuel costs. The higher this rating, the lower your fuel bills are likely to be.

Your current rating is **band E (42)**. The average rating for EPCs in Scotland is **band D (61)**.

The potential rating shows the effect of undertaking all of the improvement measures listed within your recommendations report.

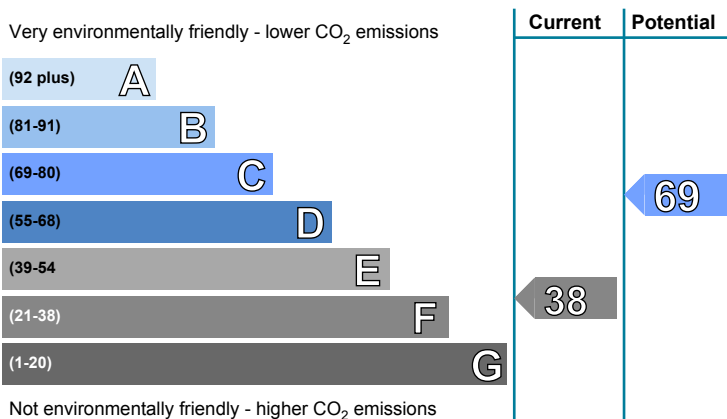
Environmental Impact (CO₂) Rating

This graph shows the effect of your home on the environment in terms of carbon dioxide (CO₂) emissions. The higher the rating, the less impact it has on the environment.
