HOME REPORT

KIMBERLEY HOUSE MAIN STREET

KIRKCONNEL
SANQUHAR
DG4 6LU

DM HALL
CHARTERED SURVEYORS

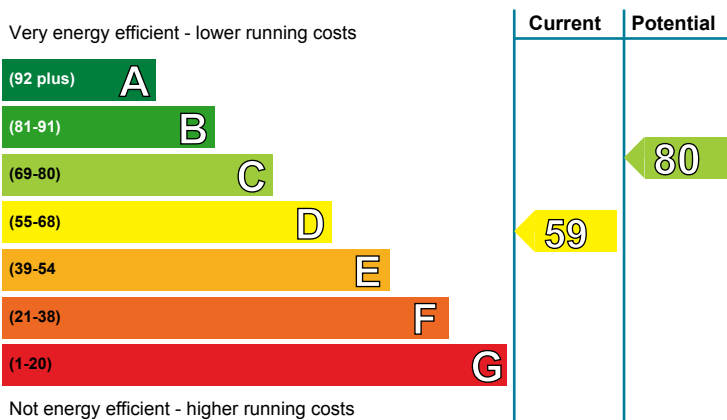
Energy Efficiency Rating

This graph shows the current efficiency of your home, taking into account both energy efficiency and fuel costs. The higher this rating, the lower your fuel bills are likely to be.

Your current rating is **band D (59)**. The average rating for EPCs in Scotland is **band D (61)**.

The potential rating shows the effect of undertaking all of the improvement measures listed within your recommendations report.
